CONFIDENTIAL INSPECTION REPORT

5678 Main Street, Lawrence, Kansas 66044

1/26/2006 9:00 am to 11:00 am

SUMMARY REPORT

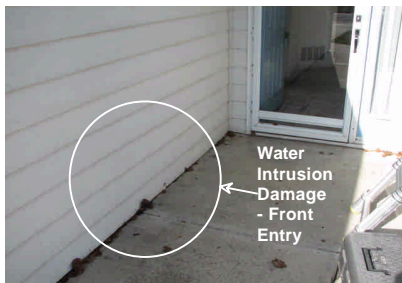
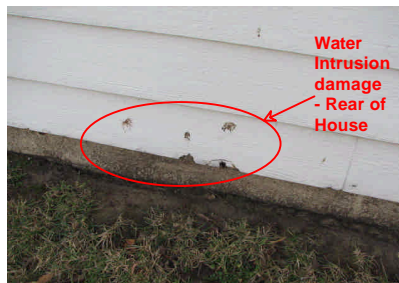
- Portions of the bottom course of lapped hardboard siding are slightly damaged by water intrusion caused by capillary action. These boards will eventually need replacement.

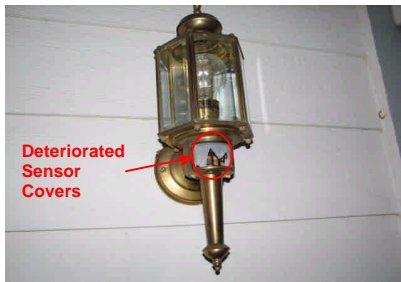
- The two (2) exterior motion detector lamps on either side of the garage door should be replaced. Ultra-violet rays have deteriorated the sensor covers. The probability of finding replacement sensor covers is unlikely.

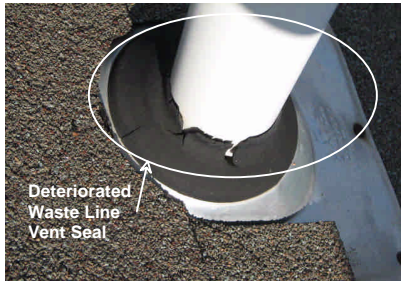
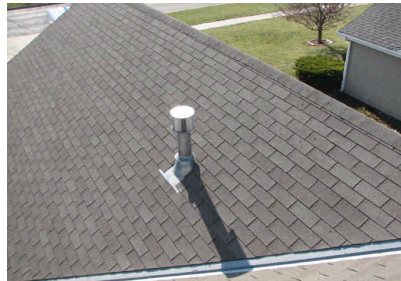
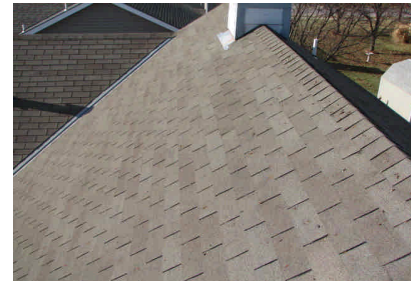
- The plumbing vents that extend through the roofing covering material are deteriorated. The roofjacks will need to be replaced to avoid water intrusion into the dwelling.

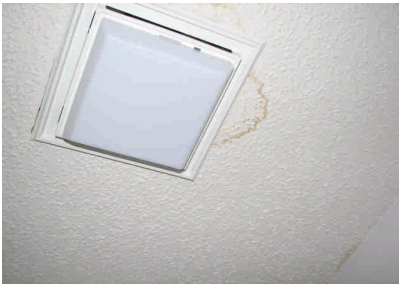
- There is moisture stains around the bathroom fan directly above the toilet. This stain is caused by a current leak as a result of a deteriorated roofjack seal which is discussed in the roofing section of this report.

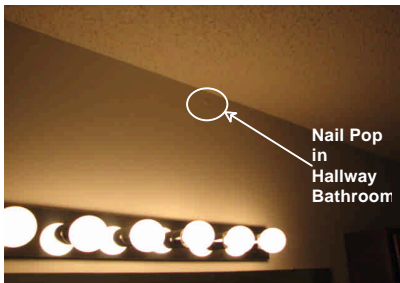
- The walls have a "nail pop" directly above the sink and you may wish to have this cosmetic flaw repaired.
