CONFIDENTIAL INSPECTION REPORT

5678 Main Street, Lawrence, Kansas 66044

1/26/2006 9:00 am to 11:00 am

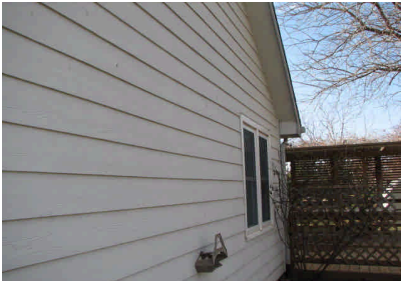
The house exterior walls are finished with hardboard lapped boards.

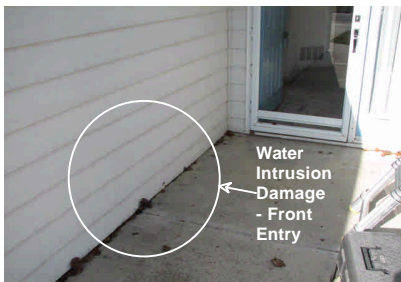
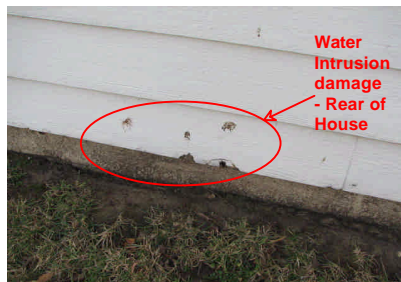
Portions of the bottom course of lapped hardboard siding are slightly damaged by water intrusion caused by capillary action. These boards will eventually need replacement.

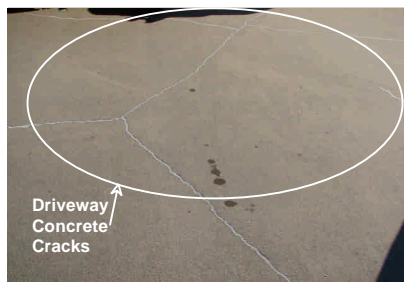
There are obvious cracks in the driveway but they have been sealed and replacement is not warranted at this time. You should monitor the driveway regularly and keep the existing cracks properly sealed to avoid water intrusion under the concrete. This will extend the life of the driveway.

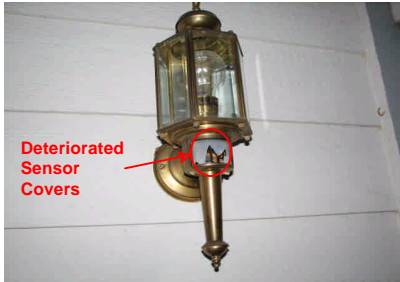
The two (2) exterior motion detector lamps on either side of the garage door should be replaced. Ultra-violet rays have deteriorated the sensor covers. The probability of finding replacement sensor covers is unlikely.

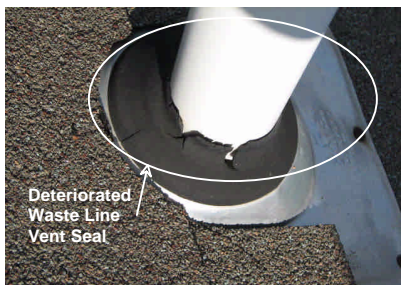
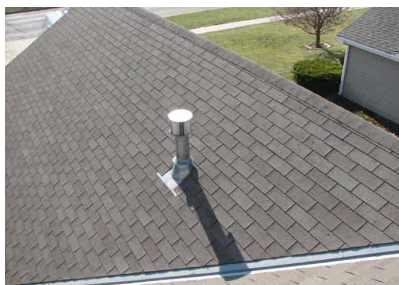
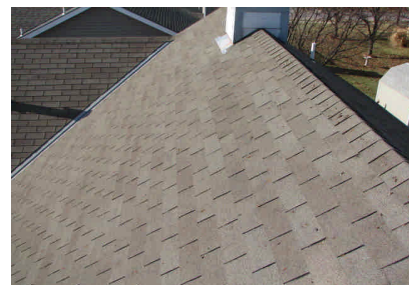
The plumbing vents that extend through the roofing covering material are deteriorated. The roofjacks will need to be replaced to avoid water intrusion into the dwelling.

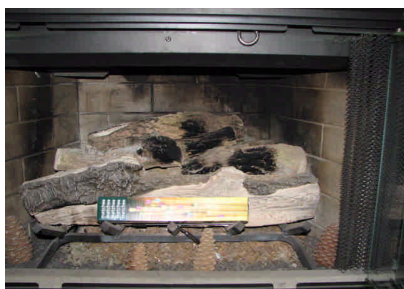
The fireplace is in acceptable condition.

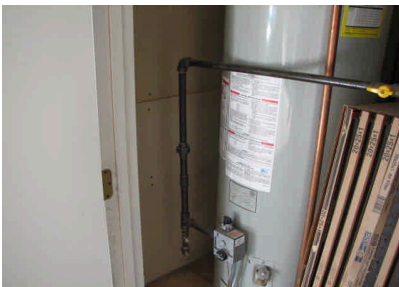
Hot water is provided by a 14 year old, 40 gallon water heater that is located in the garage.

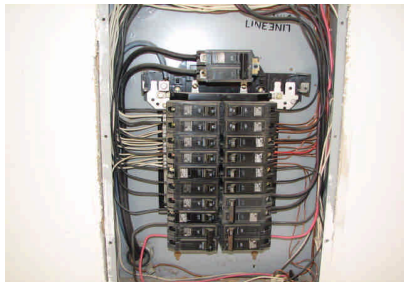
The visible portions of the wiring has no visible deficiencies.

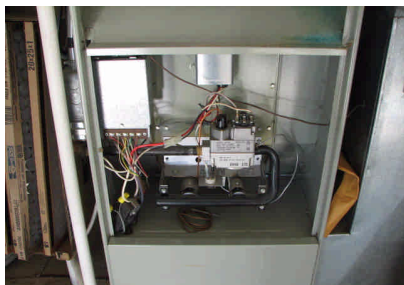
The furnace is functional.

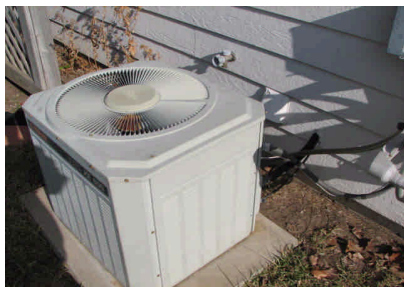
The condensing coil was not tested due to the ambient temperature being below 65 degrees, however a visual inspection of the condensing coil did not reflect any visible deficiencies.

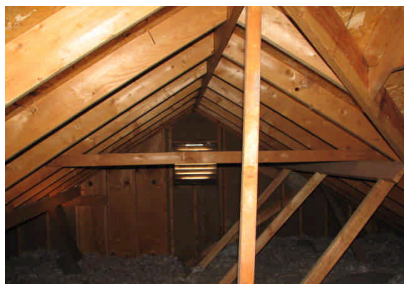
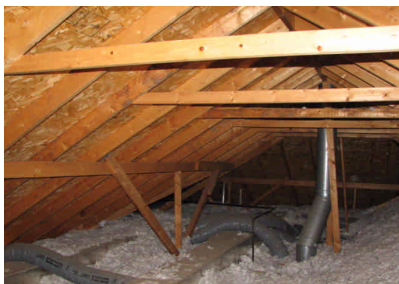
The visible portions of the conventionally stacked roof framing are in acceptable condition, and would conform to the standards of the year in which they were installed.

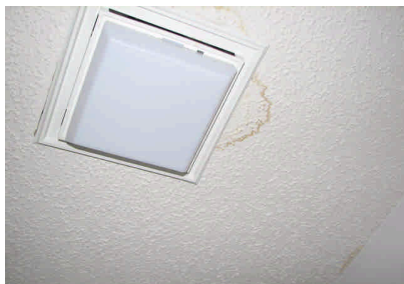
There is moisture stains around the bathroom fan directly above the toilet. This stain is caused by a current leak as a result of a deteriorated roofjack seal which is discussed in the roofing section of this report.

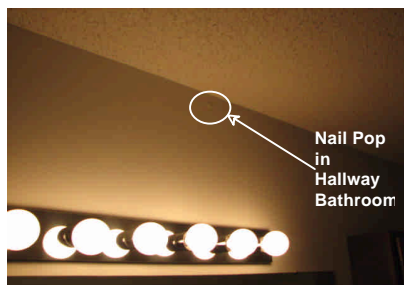
The walls have a "nail pop" directly above the sink and you may wish to have this cosmetic flaw repaired.
